**ANIMAL VEHICLE CRASH
MITIGATION USING
ADVANCED TECHNOLOGY
PHASE I: REVIEW, DESIGN AND
IMPLEMENTATION**

Final Report

SPR-3(076)

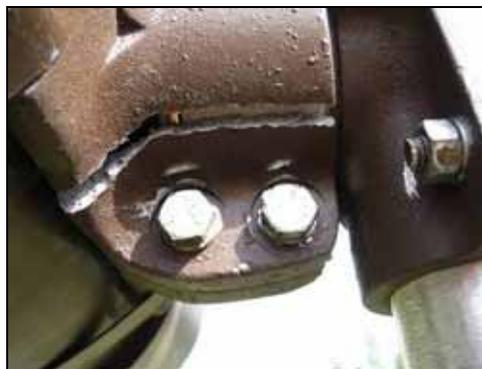
Figure 6.8: The brackets holding the sensors cracked as a result of extreme temperature fluctuations at the MT site
(Photo: Marcel Huijser, WTI-MSU)

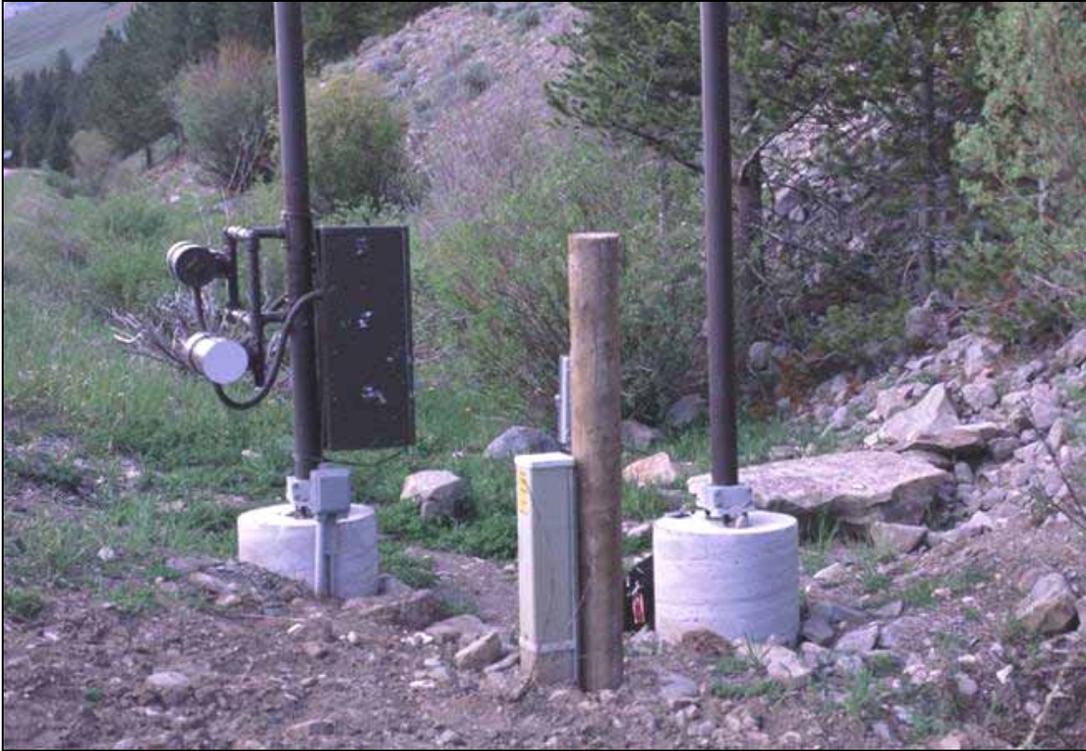
Figure 8.1: Some of the concrete foundations were in the clear zone and too high above the ground. This is the master station. The wooden post on the foreground is for the link to the land-based phone line. (Photo: Marcel Huijser, WTI-MSU)

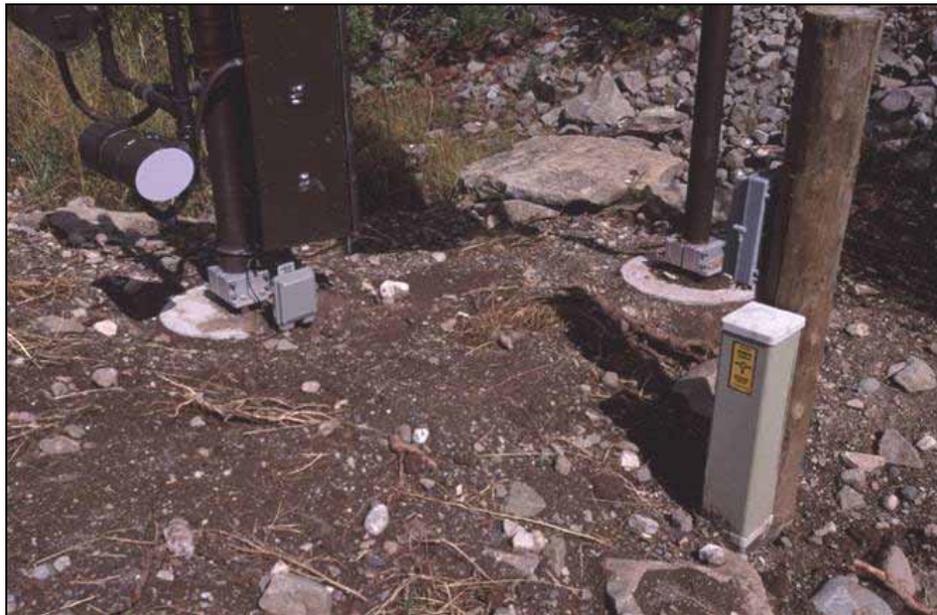
Figure 8.2: The problem with some of the concrete foundations was addressed by putting weed free soil around the posts while not blocking the drainage from the road. (Photo: Marcel Huijser, WTI-MSU)
