Use of video surveillance to assess wildlife behavior and use of wildlife underpasses in Arizona

Gagnon JW, Schweinsburg RE, Dodd NL and Manzo AL. 2006. Use of video surveillance to assess wildlife behavior and use of wildlife underpasses in Arizona. IN: Proceedings of the 2005 International Conference on Ecology and Transportation, Eds. Irwin CL, Garrett P, McDermott KP. Center for Transportation and the Environment, North Carolina State University, Raleigh, NC: pp. 534-544.

USE OF VIDEO SURVEILLANCE TO ASSESS WILDLIFE BEHAVIOR AND USE OF WILDLIFE UNDERPASSES IN ARIZONA

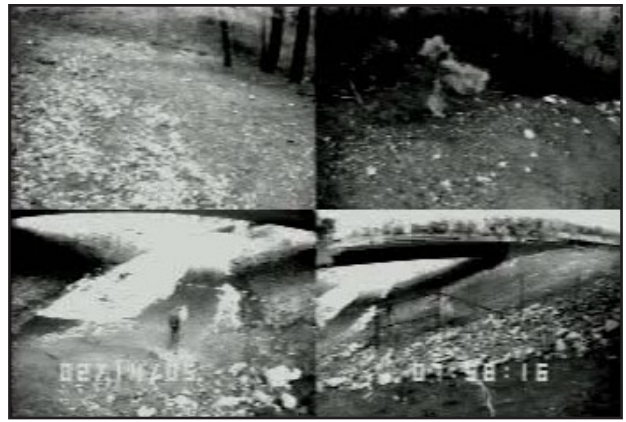
We used integrated, four-camera wildlife video surveillance systems to monitor each of the six underpasses. Two cameras were oriented in a manner to document approaches by wildlife within approximately 50 m of the underpass, one camera was placed in the underpass to assess usage and behavior within the underpass, and one camera was oriented toward the highway to assess traffic (fig. 1). A quad screen splitter allowed for simultaneous viewing of all four cameras (fig. 1). Eight to twelve infrared illuminators were incorporated to allow night-time viewing of wildlife. Infrared photo-beam triggers encompassed the area around the underpass to allow video recording only when wildlife was in the area. Systems comprised both solar and 120-volt A.C. power sources converted to 12-volt to operate equipment.

Figure 1. Typical camera orientation and quad screen view of 4-camera wildlife video surveillance systems.

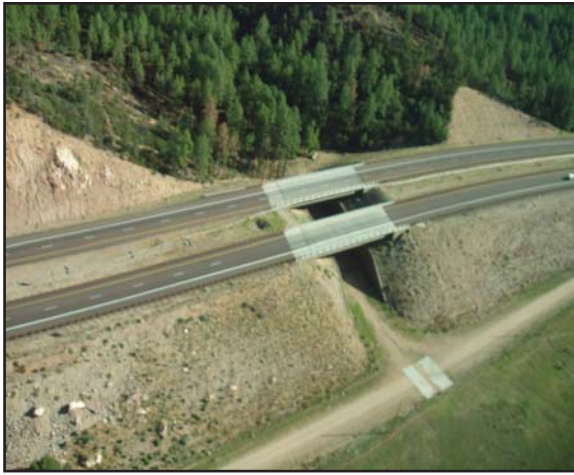
Year completed:	2001	
Dimensions:	-Span distance - 37.7 m	
	-Maximum height - 11.5 m	
	-Width at floor - 16.0 m	
	-Total length (approach to approach) - 110.6 m	
Features:	-Divided highway (11.0-m atrium between bridges)	
	-Mechanically stabilized earth (MSE) walls to 6.4 m height	
	-Limited (400-m) wildlife-proof fencing along highway linking the underpass to the East Little Green Valley Underpass	
Total Usage:	623 animals	Passage Rate: 53.5% Total Monitoring: 31 months

Figure 2. West Little Green Valley Underpass.

Example 1: Above are the 2 underpasses located within 225 m of each other and feeding into the same riparian meadow (see figs. 2 and 3 for details). The one on the left has had >3X the number of elk and a relatively higher passage rate. Why? Tunnel effect / openness ratio? Unnatural feel of concrete walls? Ledges for predators to hide?

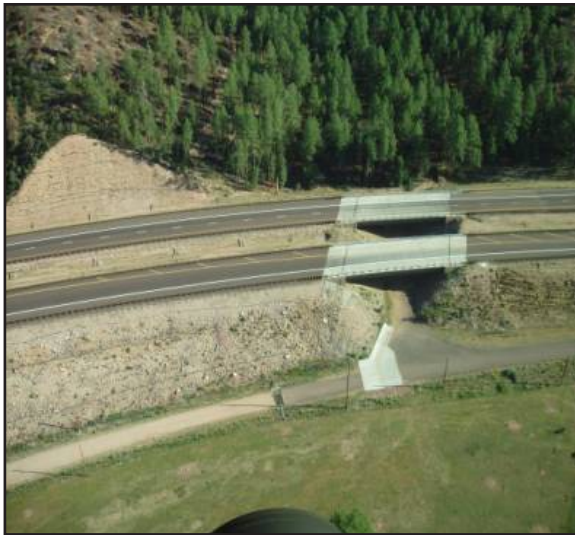
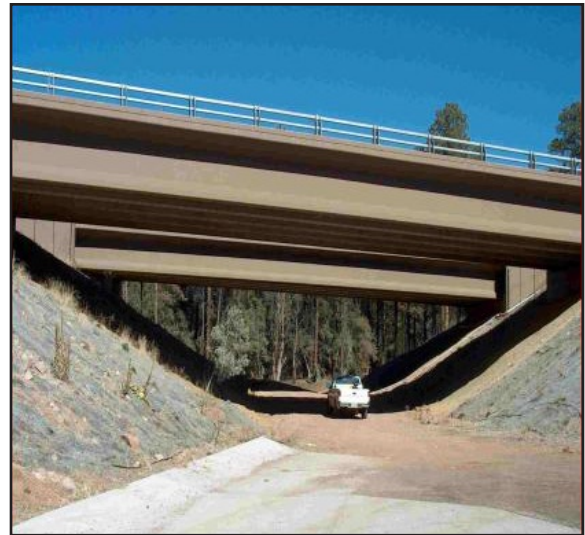
Dimensions:
 -Span distance - 37.7 m
 -Maximum height - 6.8 m
 -Width at floor - 9.6 m
 -Total length (approach to approach) - 52.7 m

Features:
 -Divided highway (11.0-m atrium between bridges)
 -2:1 sloped earthen sides
 -Limited (400-m) wildlife-proof fencing along highway linking the underpass to the West Little Green Valley Underpass (fencing tied into abutments)

Total Usage: **1,955 animals** Passage Rate: **70.1%** Total Monitoring: **31 months**

Figure 3. East Little Green Valley Underpass.

Example 3: Above are 2 underpasses that have had about the same number of deer approaches (see figs. 3 and 4 for details). The underpass on the left has only a 3% passage rate for deer, while the one on the right is at 59%. Some possible reasons for this may be the lack of cover on one side of the underpass on the left, or the large atrium created by the wide median at the underpass on the right, allowing deer to “take a break” before crossing under the second set of lanes.

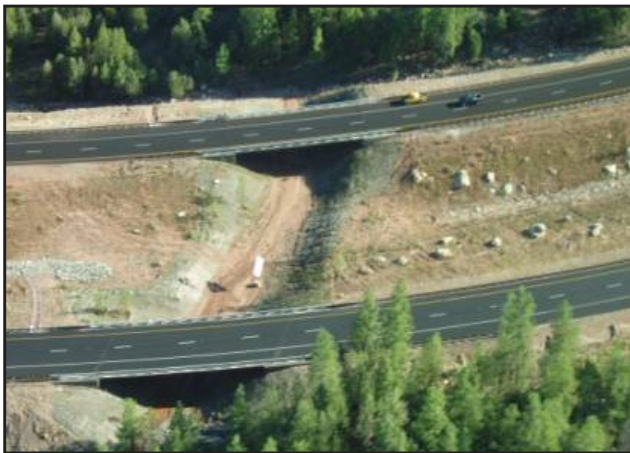
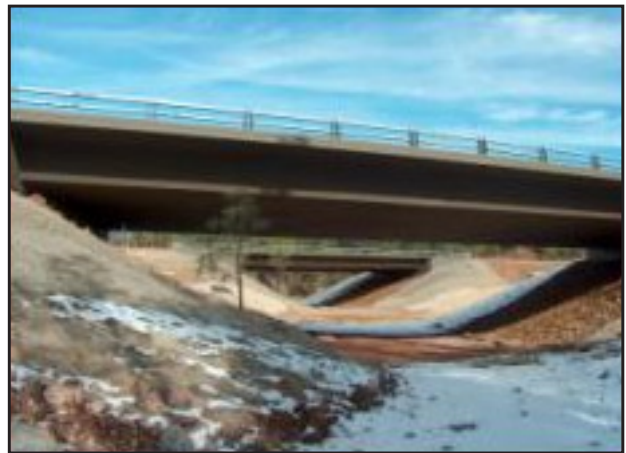
Dimensions: -Span distance – 34.2 m (east-bound)
31.9 m (west-bound)

-Maximum height – 6.8 m
-Width at floor – 7-9 m
-Total length (approach to approach) - 128 m

Features: -Divided highway (47.9-m atrium between bridges)
-This underpass also serves as a pedestrian underpass linking 2 communities (Christopher Creek and Hunter Creek)
-Wildlife-proof fencing extends >2 km to the east, funneling animals to the underpass; to the west, large, steep fill slopes and right-of-way fencing at the top of the slope behind a guard rail should also serve to funnel animals to the underpass.

Total Usage: **407 animals** Passage Rate: **63.3%** Total Monitoring: **15 months**

Figure 4. Pedestrian-Wildlife Underpass.

We monitored two wildlife underpasses for eight months prior to and six months following the completion of ungulate-proof funnel fencing. The two underpasses were constructed on a four-lane divided highway with a wide median (figs. 4 and 5).

Example 4: Above are 2 underpasses within about 2 km of each other (see figs. 4 and 5 for details). The underpass on the left has a passage rate for elk at about 27%, while the one on the right is about 59%. One possibility may be the offset of the underpass on the left minimizing the point where an elk can see all the way through the underpass. The width of the medians is approximately the same size (photos are taken at different heights). Long-term monitoring here may be important to determine if passage rate increases over time as elk learn these structures.

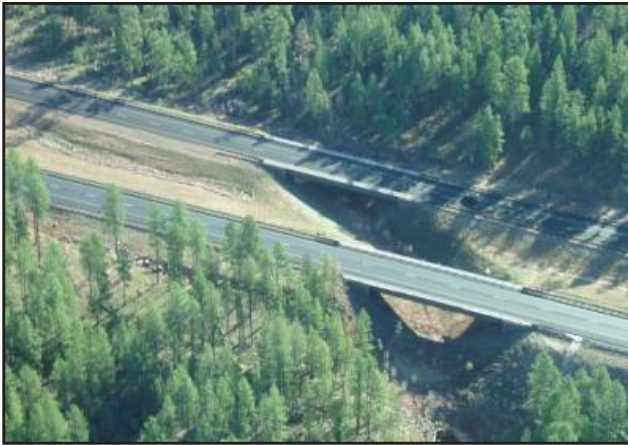
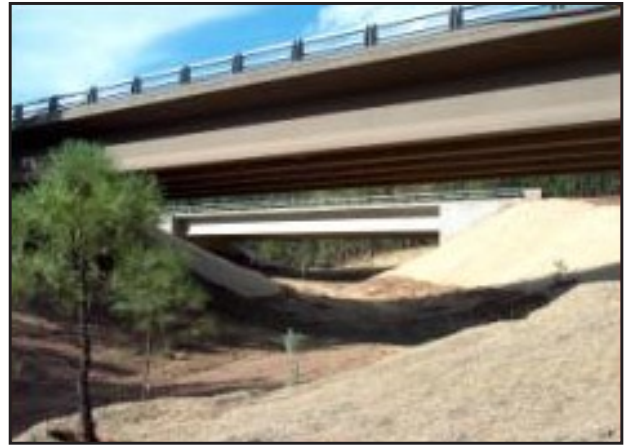
Dimensions: -Span distance – 39.9 m
-Maximum height – 10.0 m
-Width at floor – 8-10 m

-Total length (approach to approach) - 118.8 m

Features: -Divided highway (31.9-m atrium between bridges), with the bridges offset (fill material was removed to improve the sight distance through the atrium)
-2:1 sloped earthen sides
-Wildlife-proof fencing extends >2 km in each direction, funneling wildlife toward the underpass. Fencing through the underpass was completed mid-October 2004 (15 m wide)

Total Usage: **281 animals** Passage Rate: **31.6%** Total Monitoring: **15 months**

Figure 5. Wildlife Underpass #2.

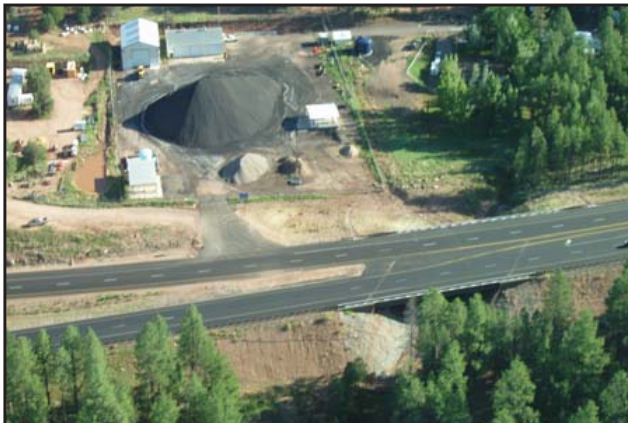
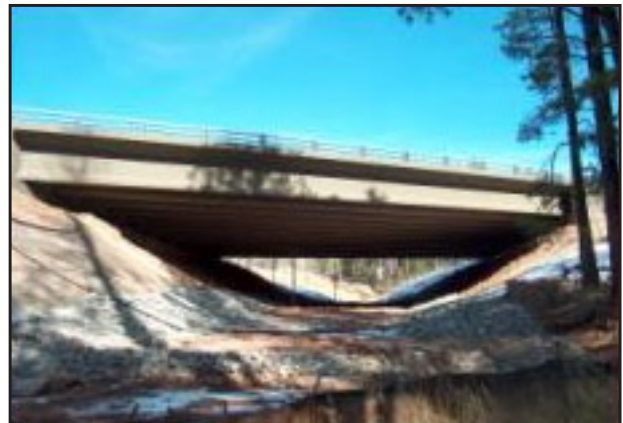
Dimensions: -Span distance – 37.7 m
 -Maximum height – 5.1 m
 -Width at floor – 10 m
 -Total length (approach to approach) – 63.9 m

Features: -Undivided highway (no atrium),
 -2:1 sloped earthen (rip-rap rock) sides
 -Wildlife-proof fencing extends 0.5 km in each direction, funneling wildlife toward the underpass. Fencing ties into the bridge abutments.
 -This underpass is located in close proximity (<0.25 km) to an ADOT maintenance yard and residence (directly in line with the north underpass approach), potentially limiting wildlife use

Total Usage: **111 animals** Passage Rate: **37.7%** Total Monitoring: **15 months**

Figure 6. Wildlife Underpass #3.

Example 2: Above is an underpass (see fig. 6 for details) that has shown very little use and very low passage rates (except for raccoon (*Procyon lotor*), this is probably due to the placement of the structure being so close to human activity. This underpass also lacks an atrium, forcing animals to cross under four lanes at once.

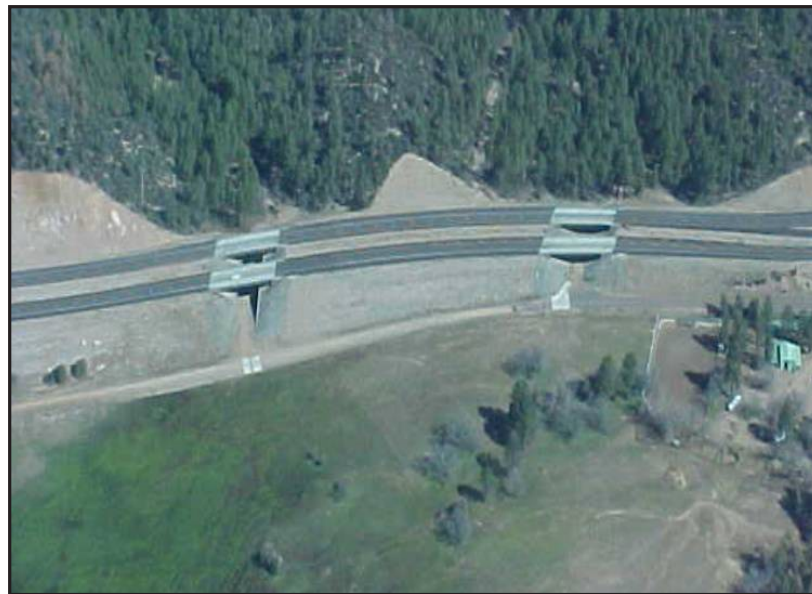
Figure 7. Aerial photo of the adjacent West (left) and East Little Green Valley underpasses on the Preacher Canyon section. These 2 underpasses are only 225 m apart, allowing for a unique opportunity to compare underpass designs.

Arizona Game and Fish Department (AZGFD) met with Arizona Department of Transportation (ADOT) and Tonto National Forest to share the data obtained from the comparison of the east and west underpasses at Little Green Valley (fig. 7). The data were used to make recommendations for changes to the Indian Gardens wildlife underpass that was in the final planning stages. The underpass, now currently under construction, has significantly less MSE wall and has been widened to minimize tunnel effect and to potentially increase wildlife usage. AZGFD will begin video monitoring of the Indian Gardens wildlife underpass in fall of 2005.

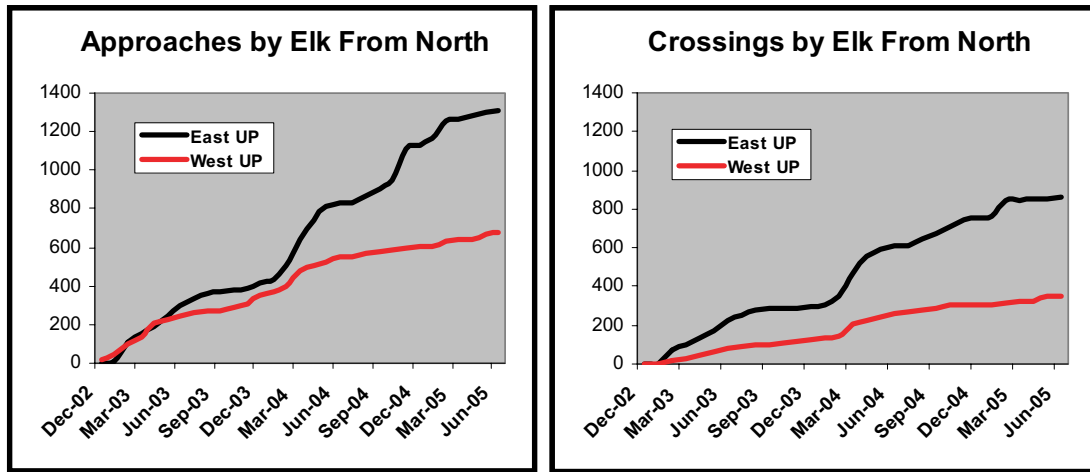
Crossings at the east Little Green Valley underpass were greater than 3 times that of crossings at the west underpass. At the east underpass 1908 elk crossed through versus 598 through the west. This difference in usage holds true whether elk are entering or leaving Little Green Valley. Comparisons of the 2 underpasses over time show that the number of animals that approached each underpass from the camera side was roughly equivalent for the first 6 months, then begins to favor the East Underpass, while crossings were always higher at the east underpass (fig. 8).

Figure 8. Approaches and crossings from camera side of east and west underpasses at Little Green Valley.

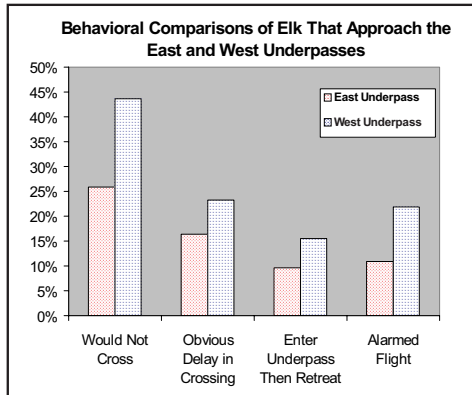
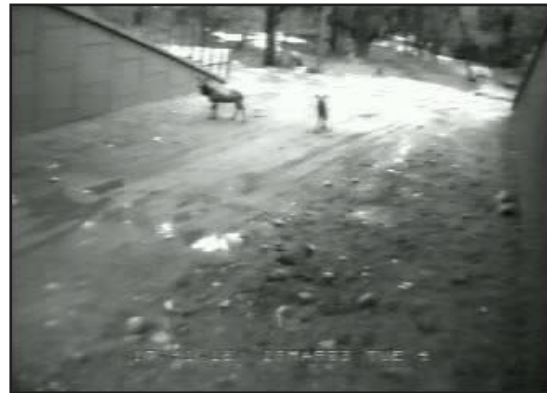
Of the individual elk that approached from the camera side of the underpasses, we identified four negative behaviors: (1) would not cross, (2) obvious delay in crossing, (3) enter underpass and retreat, and (4) alarmed flight from area. The percentage of elk that showed these negative behaviors were all higher at the west underpass (fig. 9).

Figure 9. Comparison of 4 negative behaviors associated with elk approaching each underpass and an example of elk showing hesitation immediately prior to fleeing from the area, and exhibiting an unsuccessful crossing.

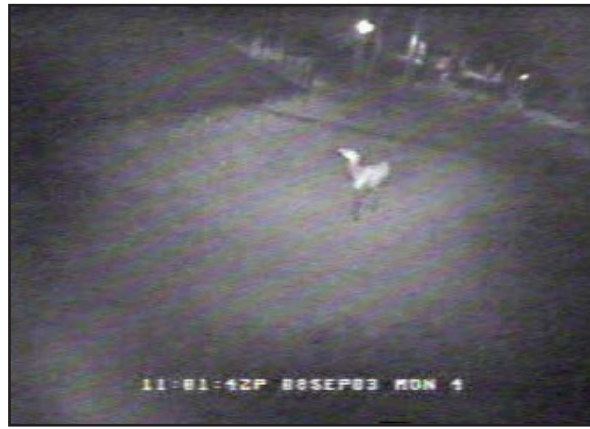
1. Natural slopes versus MSE walls – The walls may provide an unnatural feel for wildlife using them.
2. Sound / Echoes created by walls – Sound was tested at the A-weighted scale, no significant difference in decibel levels.
3. Tunnel effect / Openness ratio – The west underpass is twice the length of the east, reducing the openness.
4. Ledges for predators to hide on walls – Some animals may fear the possibility of predators hiding on the ledges of the walls (fig. 10).
5. Differences in lighting of the 2 underpasses.

Figure 10. A common sight at the west underpass of elk looking up at the top of the walls, possibly for predators.
