**ANIMAL-VEHICLE CRASH
MITIGATION USING
ADVANCED TECHNOLOGY
PHASE II: SYSTEM
EFFECTIVENESS AND SYSTEM
ACCEPTANCE**

Final Report

SPR 3(076)

March 2009

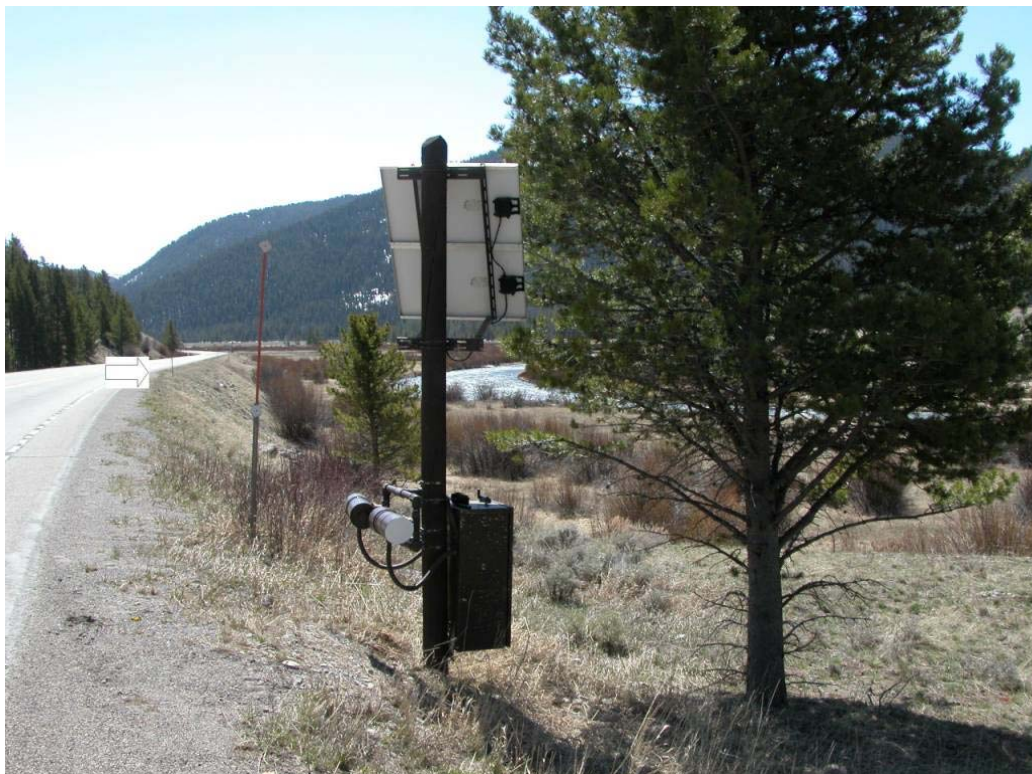
Figure 2.5: Proposed relocation of Station 11, looking south; relocated 275 ft (84 m) to the southeast (at a bend in the road, indicated by arrow) (Photo: Lloyd Salsman, STS)

The proposed system modifications included removing Station 13, relocating Station 11 (Figure 2.5), and including the entrance to the parking area for the Black Butte Trailhead in the sensor array. The Technical Advisory Committee (TAC) for the project had decided that, after system modifications, the percentage of blind spots in the total length of the system must be between 2% and 5% at a maximum. Should a higher percentage of the system have blind spots after system modification, the system would have to be removed.

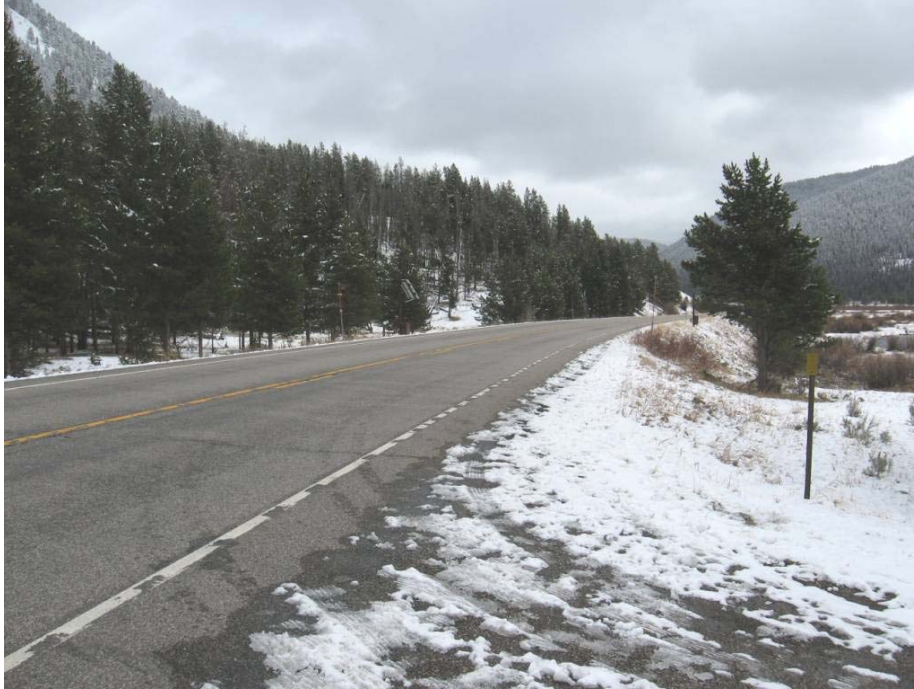
Figure 2.7: Area just south of Black Butte Trailhead after Station 13 was removed and Station 11 was relocated. Station 11 (new location) can be seen on the left side of the tree (Photo: Marcel Huijser, WTI-MSU).

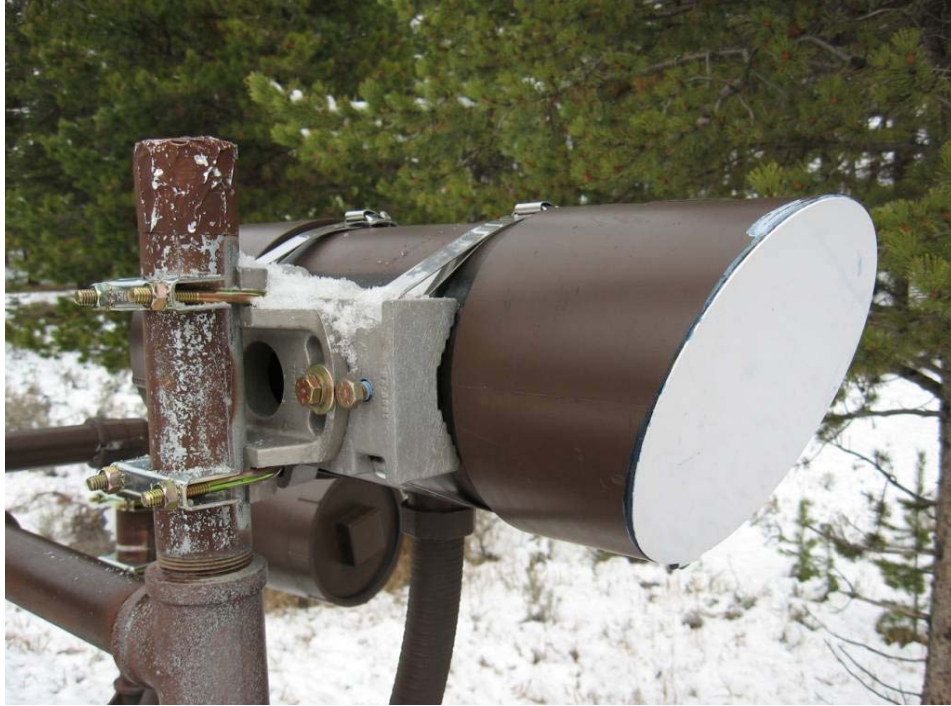
Figure 2.10: Sensor equipped with new bracket (aluminum casting, metal bands around sensor tube) (Photo: Marcel Huijser, WTI-MSU)

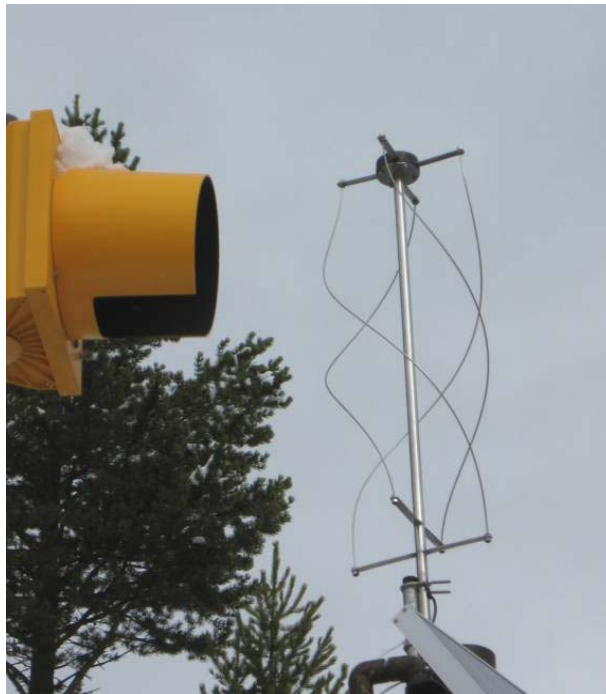
Figure 2.11: Antenna for remote access through satellite connection (Photo: Marcel Huijser, WTI-MSU)

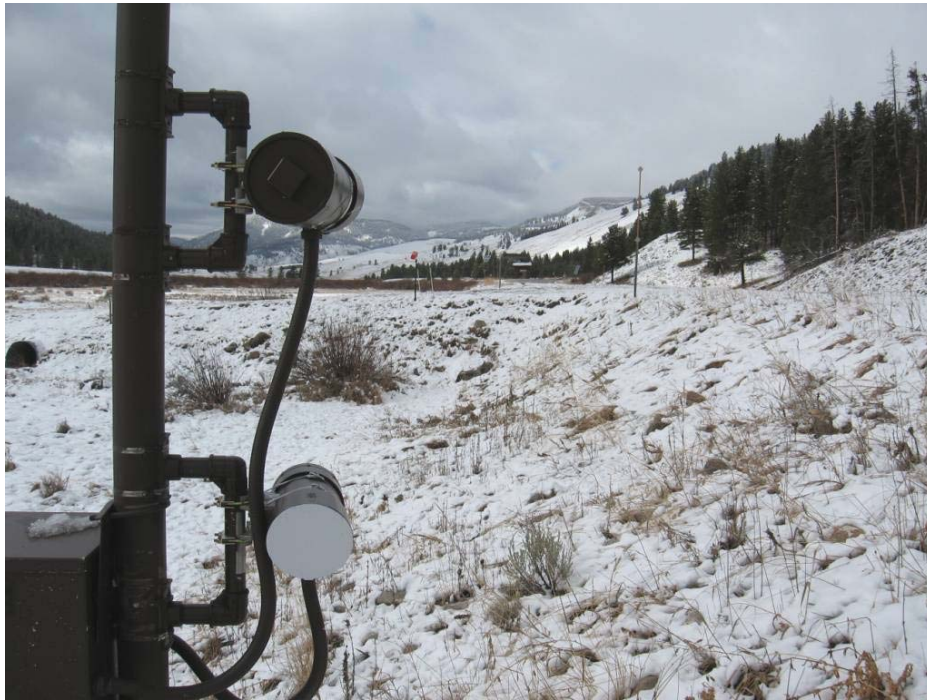
Figure 2.12: Looking north from Station 23 (Detection Zone 3) towards the Black Butte Ranch access road and Station 21. There is a blind spot in the area between Station 23 and the Black Butte access road because the sensor had to be placed high on the pole in order to shoot across the embankment of the Black Butte access road (Photo: Marcel Huijser, WTI-MSU).

The testing revealed that there were no blind spots present, except in Detection Zone 3 (55 ft (≈ 16.9 m), and Detection Zone D (60 ft (≈ 18.3 m)). The blind spots in Detection Zone 3 were related to a sensor that had to be placed high on a pole in order to shoot the beam across the Black Butte Ranch access road. The blind spot in Detection Zone D resulted from the sensor at Station 23 shooting up a slope towards Station 7. Figures 2.12 – 2.14 show these blind spots from various perspectives. The total length of the blind spots after system modifications was estimated at 115 ft (35.2 m), or 1.09% of the total length covered by the system. This number was well below the maximum percentage of allowable blind spots (5%).

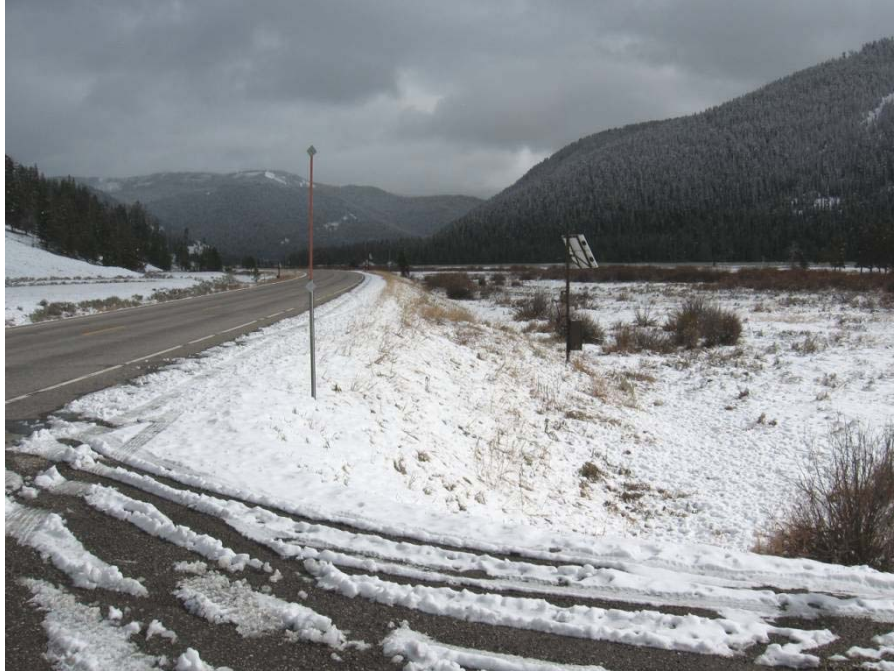
Figure 2.13: Looking south from the Black Butte Ranch access road towards Station 23. There is a blind spot in the area between the Black Butte access road and Station 23; the same blind spot is illustrated in Figure 2.12 (Photo: Marcel Huijser, WTI-MSU).

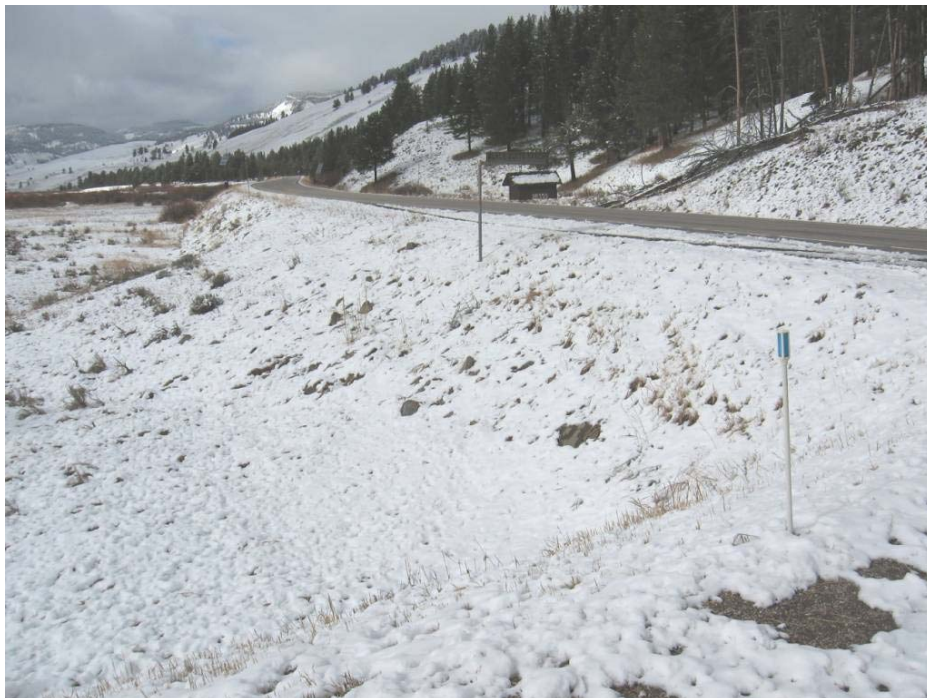
Figure 2.14: Looking north from the Black Butte Ranch access road towards Station 21. There is a blind spot in the area between the Black Butte access road and Station 21, because the sensor on Station 23 had to be placed high on the pole in order to shoot across the embankment of the Black Butte access road (see Figure 2.12) (Photo: Marcel Huijser, WTI-MSU).

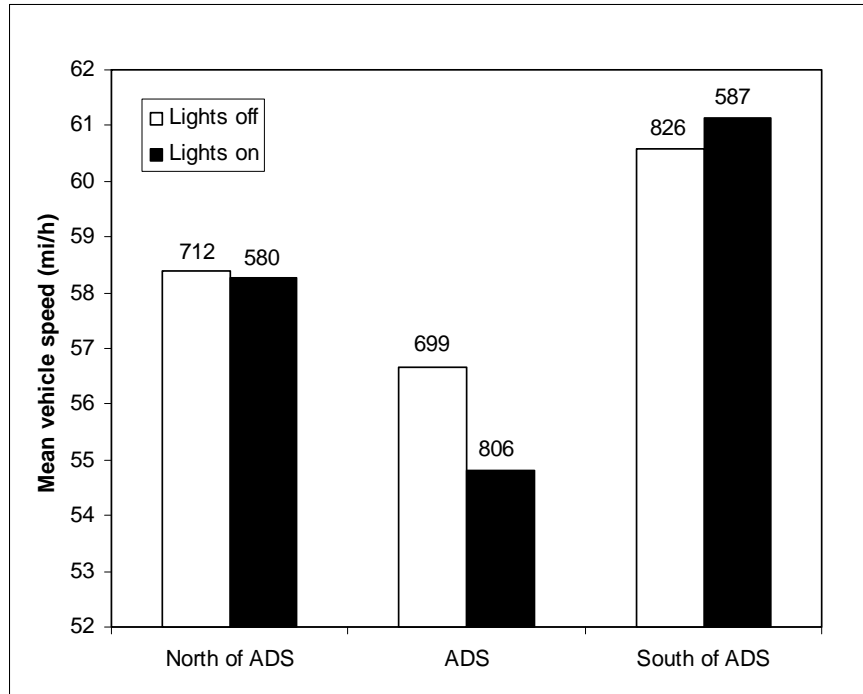
Figure 3.7: Changes in vehicle speed of passenger cars, pick-ups, and vans for southbound traffic during the day (with sample size shown above each bar)

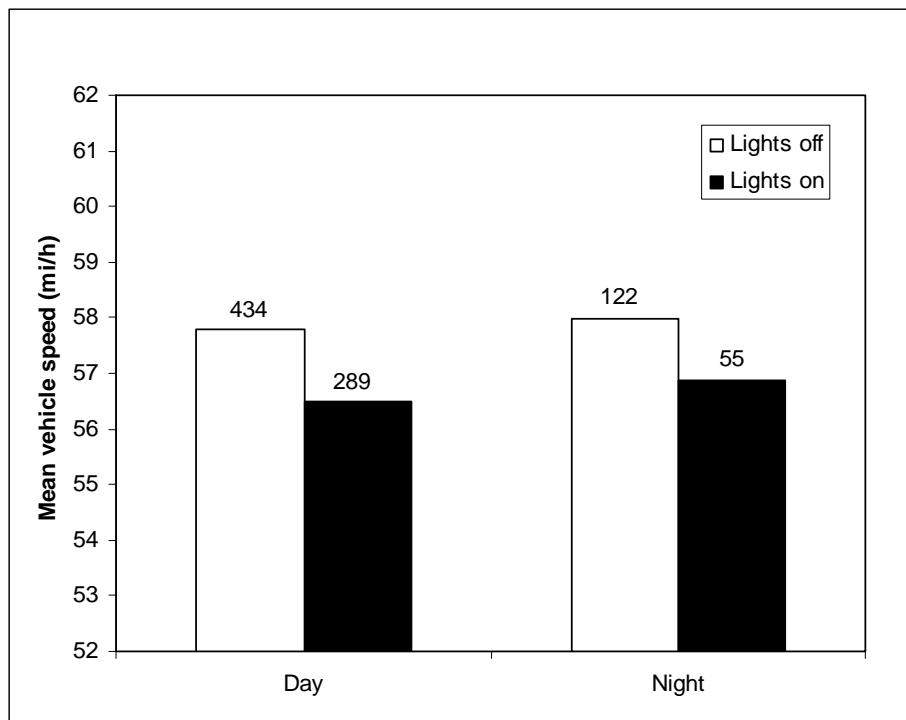
Figure 3.13: Vehicle speed of trucks with two or more units for southbound traffic (with sample size shown above each bar)

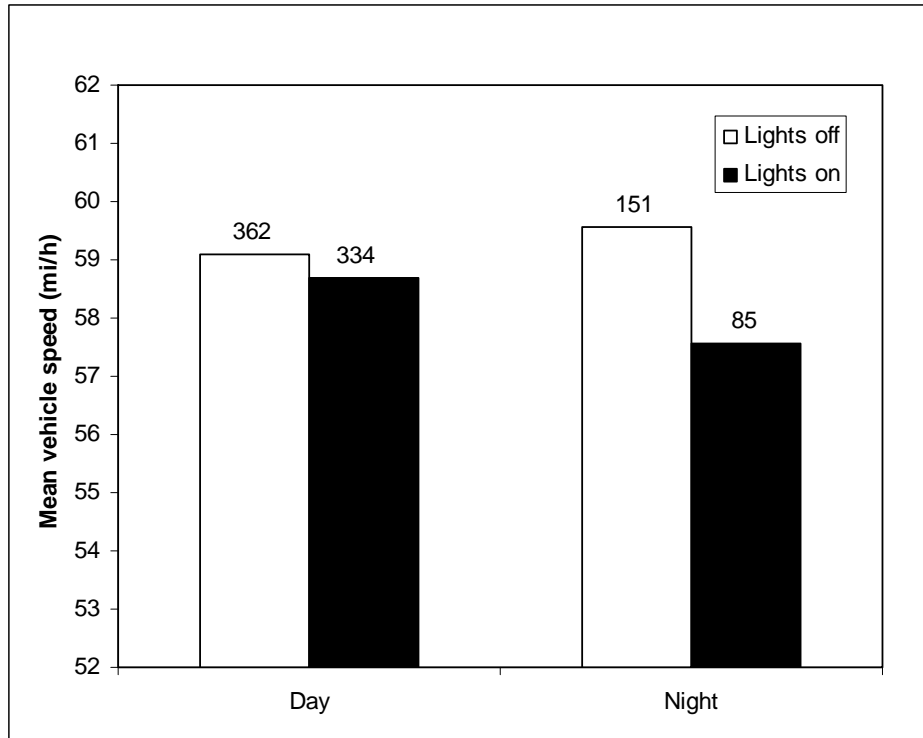
Figure 3.14: Vehicle speed of trucks with two or more units for northbound traffic (with sample size shown above each bar)

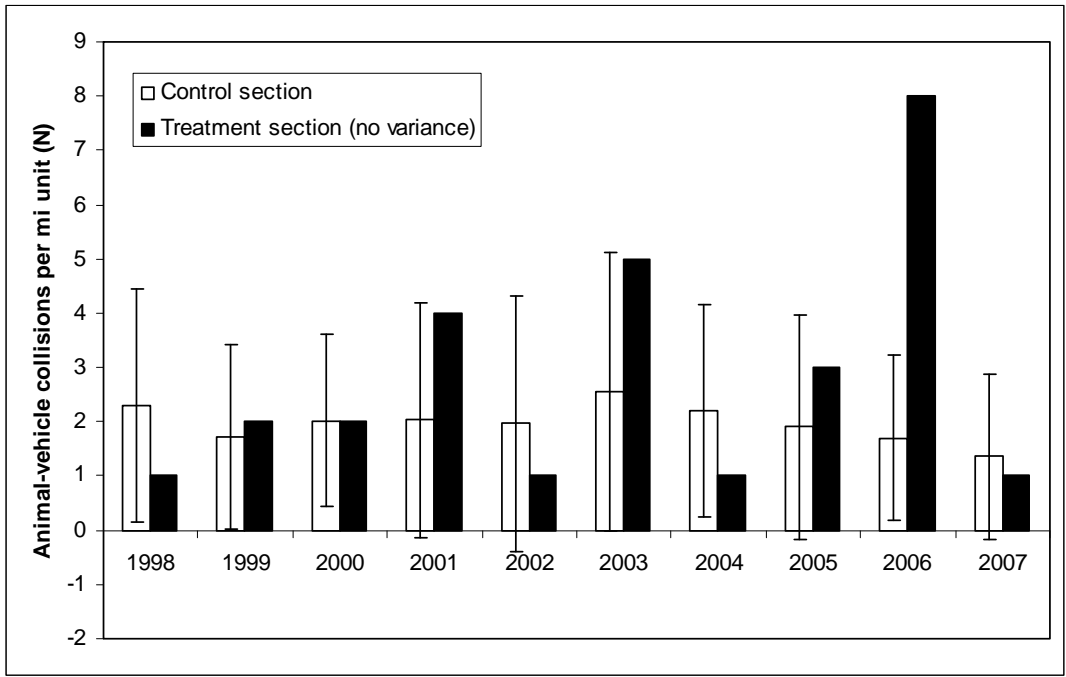
Figure 4.5: Average number (\pm SD) of reported collisions with large mammals and large mammal road mortalities from the control sections (N=59) and the treatment section before and after the system became fully operational

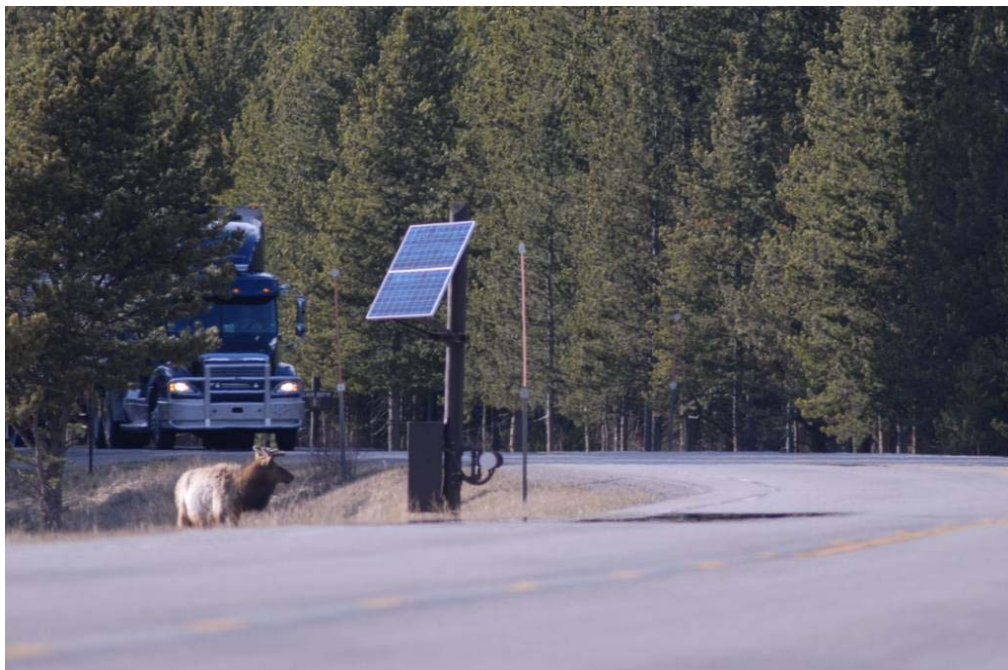
Figure 5.1: A bull elk (in velvet) approached the system on 25 April 2007, and activated the warning signs. The activated warning signs in combination with the high visibility of the elk next to the road resulted in vehicles braking and reducing speed (Personal observation Marcel Huijser, WTI-MSU) (Photo: Marcel Huijser, WTI-MSU).
